## The access ramps of the lifting platform no longer engage properly.

Artikel-Nr.: X10  
Hersteller: Krömer  
EAN-Code: 0738964858374

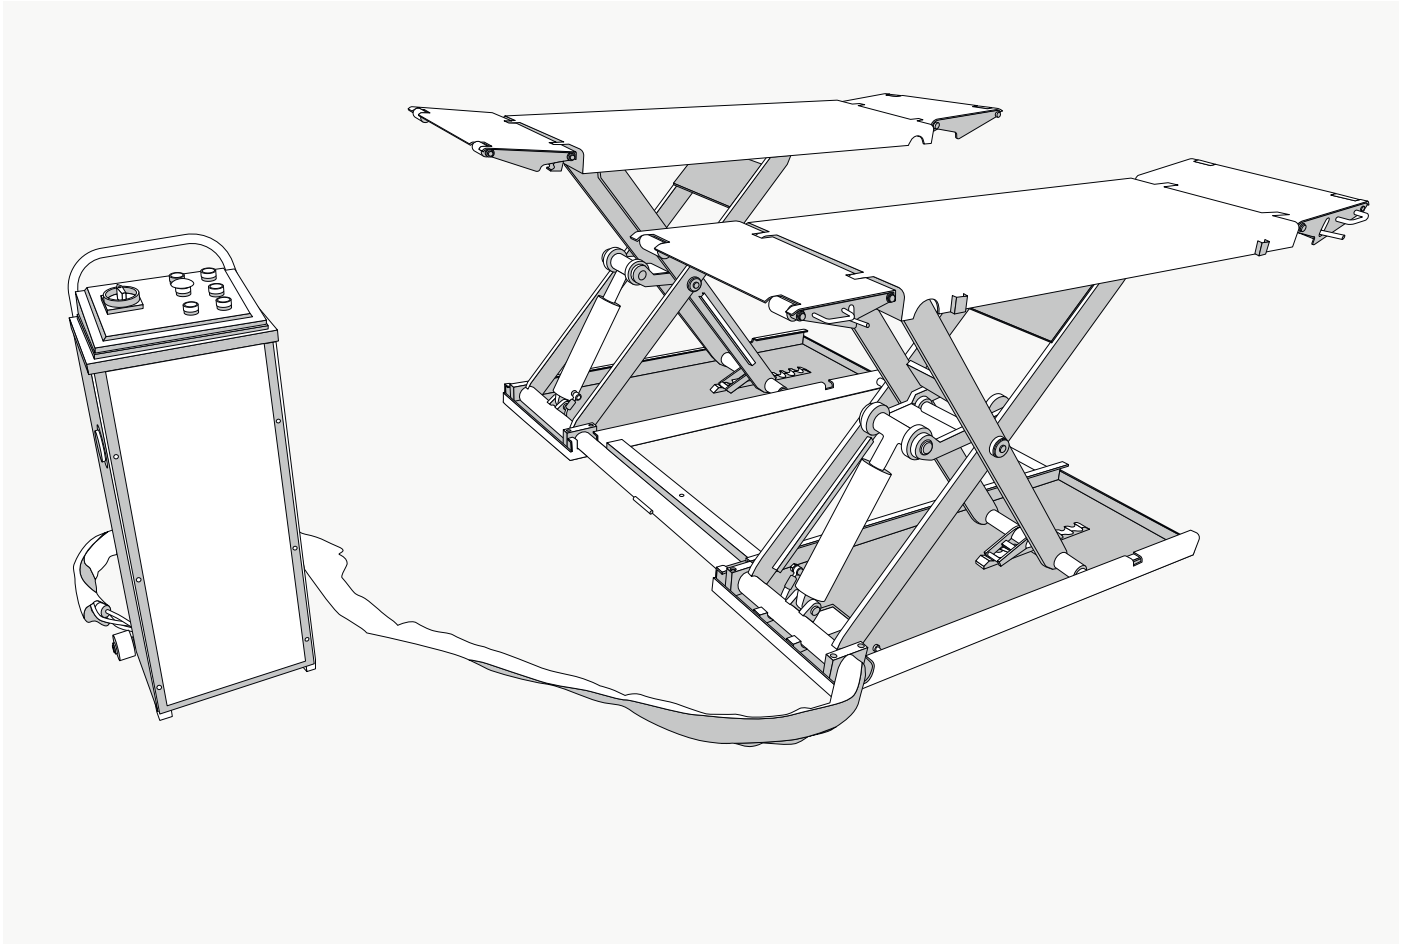
The access ramps of the lift are not level with the platforms.

The handle of the ramp pegs bent during use

Straighten the handle again.

If the ramp is bent to such an extent that manual adjustment of the handle is out of the question, the bent part of the ramp can also be sent in and replaced.

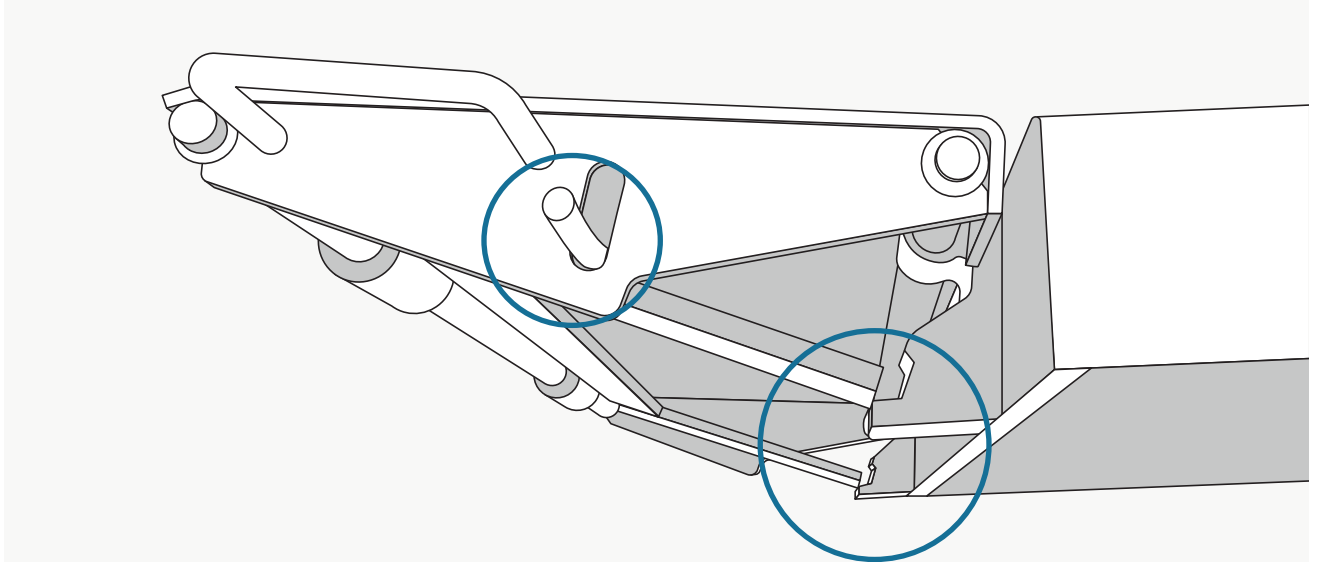
**1** Starting position 1

The ramp no longer engages properly due to the bent latch handle.
